**Jefferson Memorial Seawall Repair
Drilled Shaft Integrity Testing
ADSC's Summer Meeting Reviewed
Maximizing Selling Results at Trade Shows**

Restoring Value to a National Monument: Emergency Repair of Jefferson Memorial Seawall and North Plaza

by Helen Robinson, P.E., Schnabel Engineering, Inc.
 Darrell Wilder, P.E., Schnabel Engineering, Inc.
 Jesús Gómez, Ph.D., P.E., D.GE., Schnabel Engineering, Inc.
 Lindsey Dunn, P.E., LEED® AP, Clark Civil, LLC,
 and Brannin Beeks, P.E., Raito, Inc.

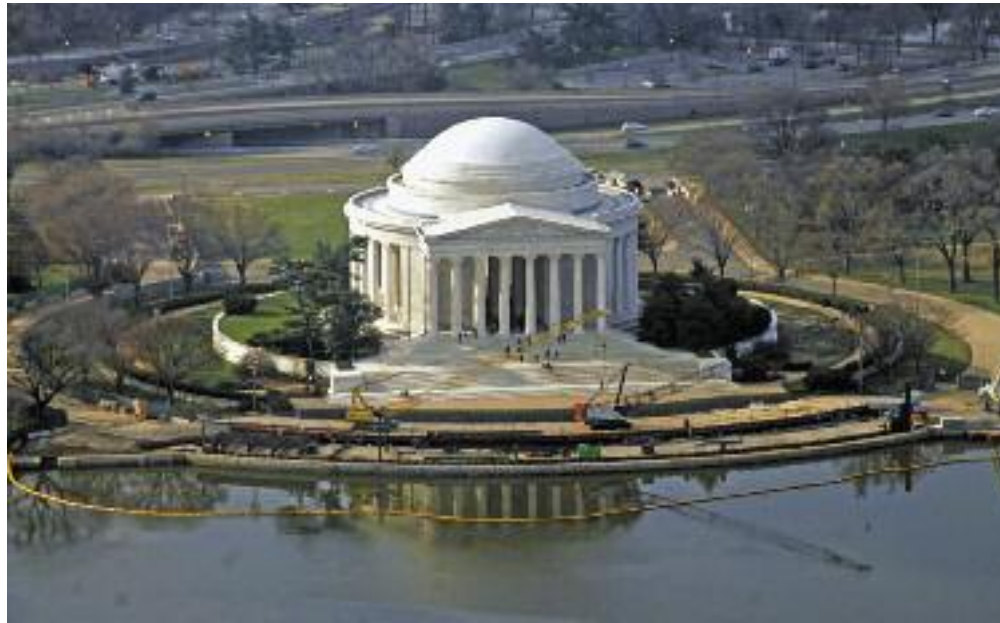
Construction activities on the North Plaza and Seawall at the Jefferson Memorial.

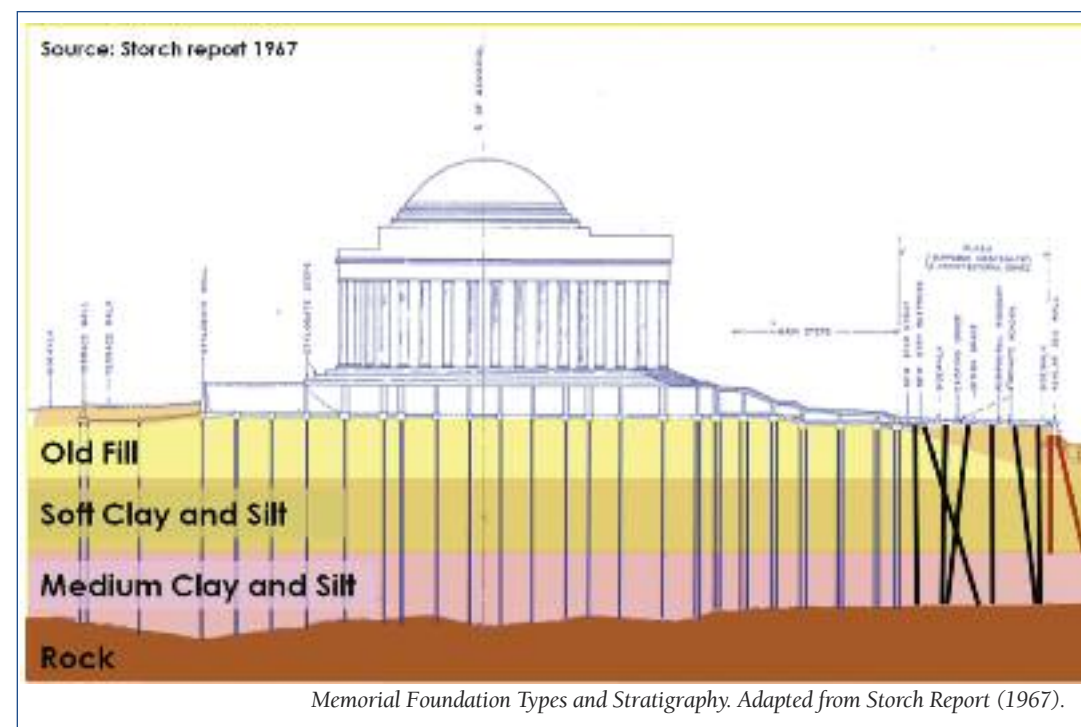
The length of the timber piles supporting the seawall was established based on the metrics of historic photos at 70 to 75 feet.

This range of length was insufficient to reach rock. The piles, however, may have reached the somewhat stiffer alluvium overlying rock.

Memorial Foundation Types and Stratigraphy. Adapted from Storch Report (1967).

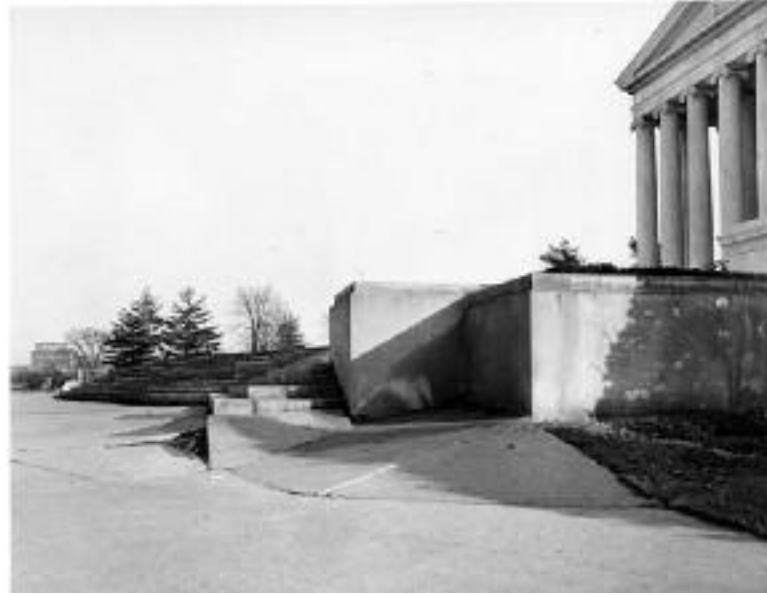
The North Plaza of the Jefferson Memorial was originally an asphalt road on grade bordered by concrete sidewalks. The plaza settled and showed considerable damage in the years following the Memorial's construction. The plaza was reconstructed in 1969-1970 as a structural slab on grade beams and HP piles. Based on construction records, the piles were extended into bedrock. This was confirmed through interviews with engineers involved with reconstruction of the North Plaza at the time.

West end of Memorial Stairs. By the 1950s, the North Plaza on grade had experienced significant settlement (the Memorial steps are supported on piles). Source: National Park Service Archives.

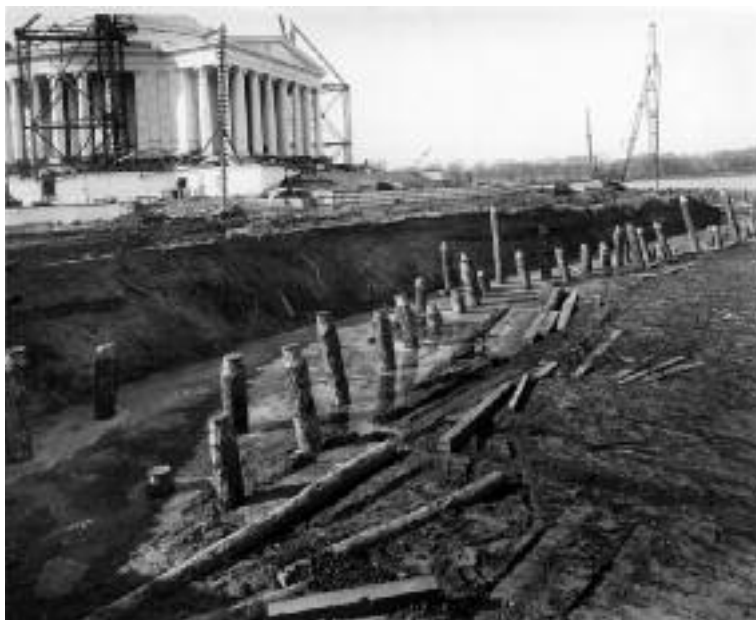
Timber Pile driving for original Seawall. What type and how long were the piles used for the Ashlar Seawall? Historic photo that answered this most important question. Notice start of pile driving in background.

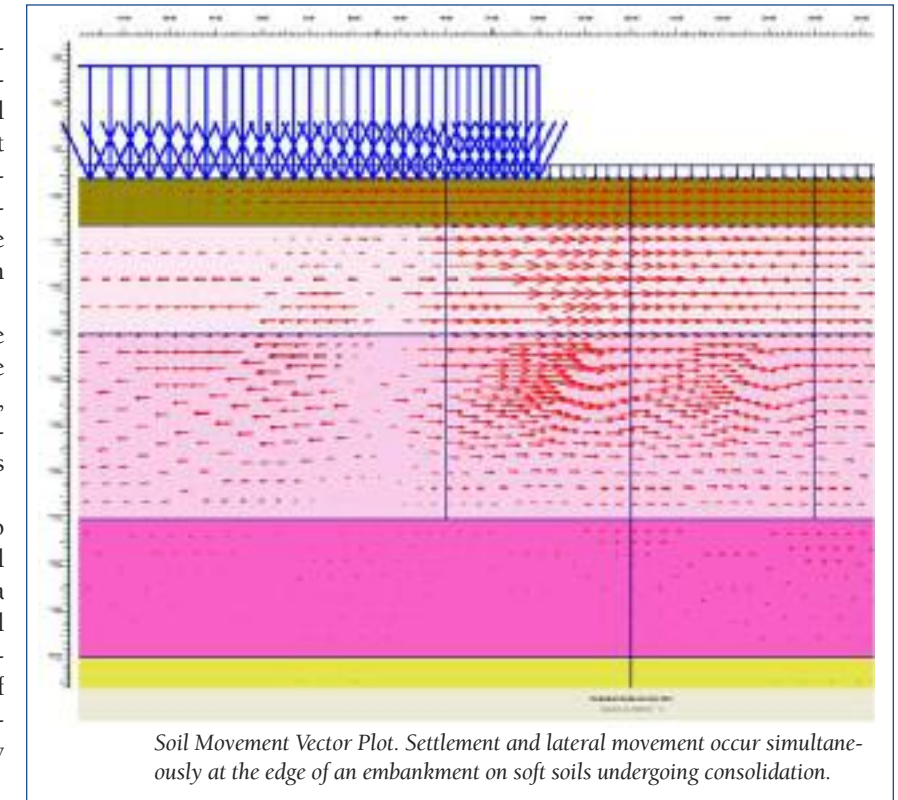
The lateral movement of the seawall is due to the effect of the proximity to the edge of the embankment. Typically, embankments placed over soft soils that undergo settlement, also undergo lateral movement near their edges. As the seawall is at the edge of the embankment, lateral movement of the subsurface soils caused the slender timber piles supporting the seawall to move laterally as well.

Soil Movement Vector Plot. Settlement and lateral movement occur simultaneously at the edge of an embankment on soft soils undergoing consolidation.

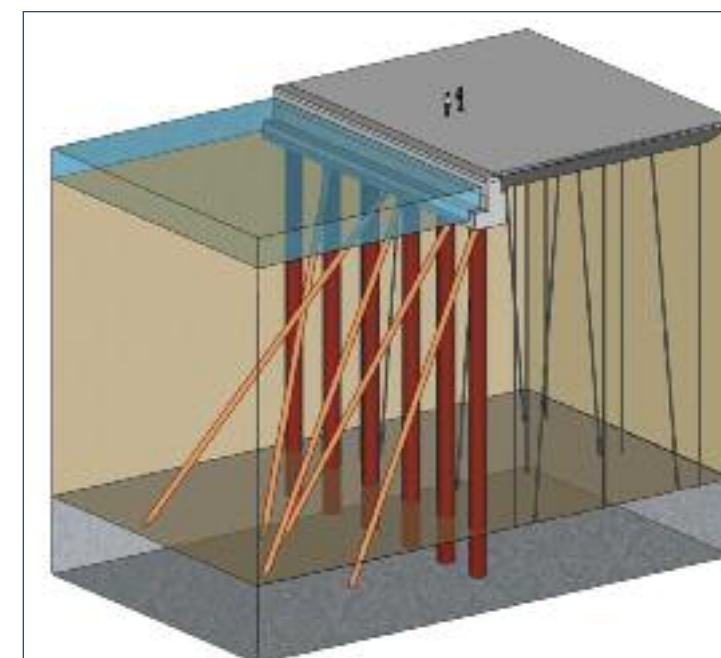
Artist's rendering of A-Wall solution.

In the adopted solution, the existing wall would be demolished after carefully removing, cataloguing and storing the Ashlar facing blocks. Caissons with a diameter of 4 feet would then be drilled and socketed into rock. Battered, 18-inch, pipe piles would be installed toward the Tidal Basin, thus avoiding conflicts with the existing North Plaza piles. The wall would be rebuilt over the caissons and piles, and would be designed as a structural connection between the foundation elements and to support the earth

The battered piles are splayed with respect to the wall in order to limit the tendency for out-of-plane movements of the system. In addition, the inclination of the piles alternated as either 25° or 35° to prevent conflicts during installation.

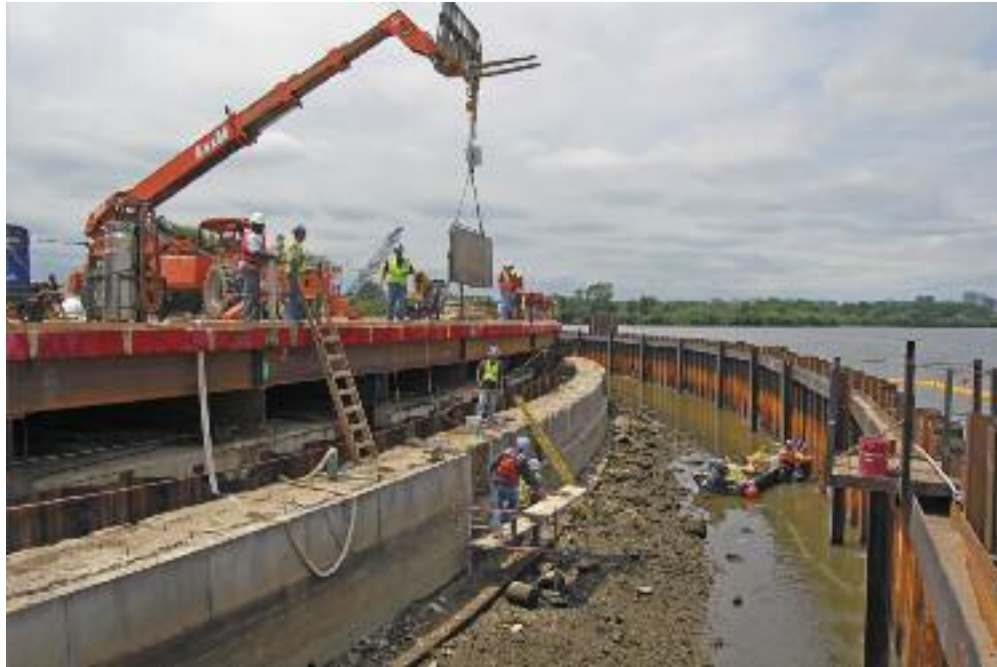
Removal of historic Ashlar facing from Seawall.

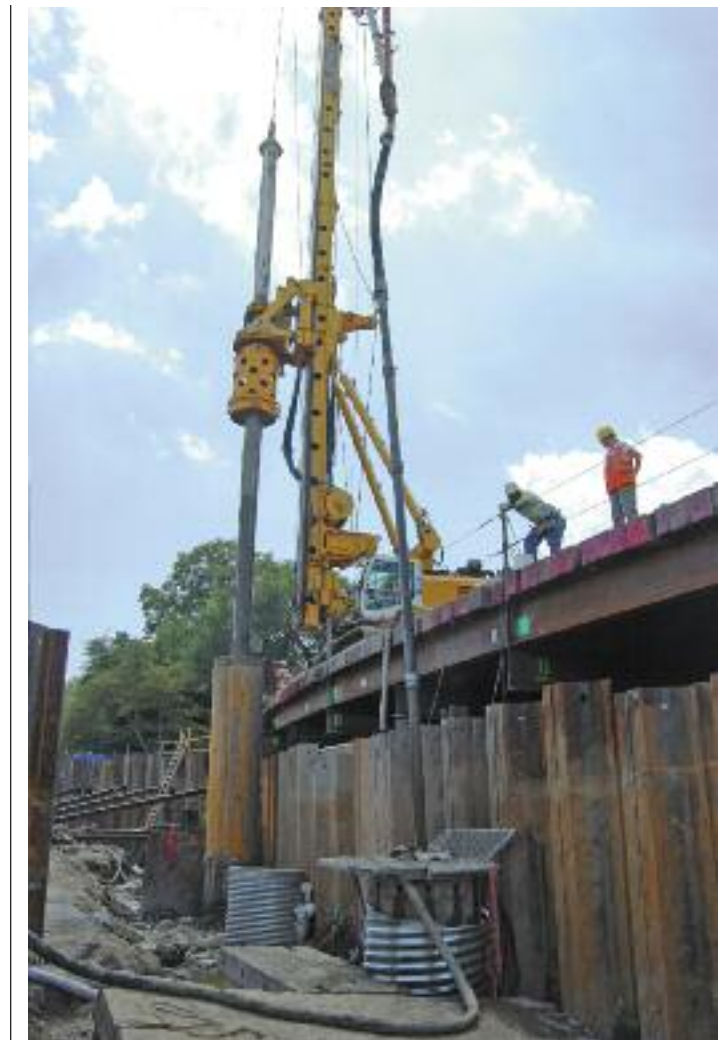
Caisson construction using the Bauer BG 40 (background) and caisson concrete tremie placement (foreground).

The final challenge consisted of moderately weathered green and black schist. Drilled shafts were socketed up to fifteen feet into rock using an ADSC Associate Member, Bauer BG40* and various

rock augers and buckets. Most shafts were allowed to sit overnight before pouring concrete the following morning. A cleanout bucket was used prior to the placement of the reinforcing cage to assure a clean shaft tip. During placement of concrete, polymer slurry

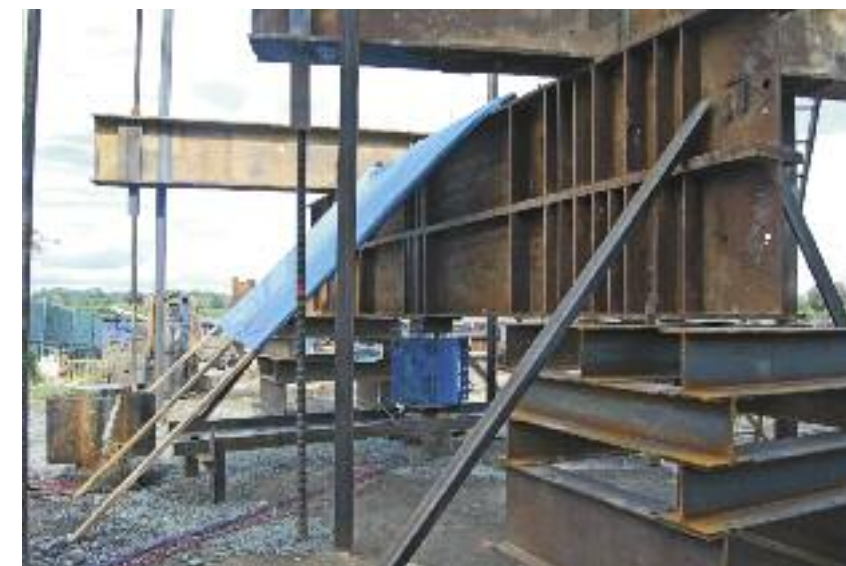
Load test setup.

did provide usable data for the load test. The two load tests were run in the ASTM D1143 Quick Method to determine the amount of settlement recorded with loads applied at 866 kips. After the instrumentation malfunctions, thought to be from the hard driving, a third load test was installed with both arc weldable gauges and sister bars installed with a center bar to provide a “belts and suspenders” approach to ensure multiple sources of data were collected in the last load test. In addition, the pile was driven to a shallower depth to collect the skin friction capacities required to verify and complete pile design. All gauges functioned correctly and adequate data was collected to verify the pipe piles would meet the design load.

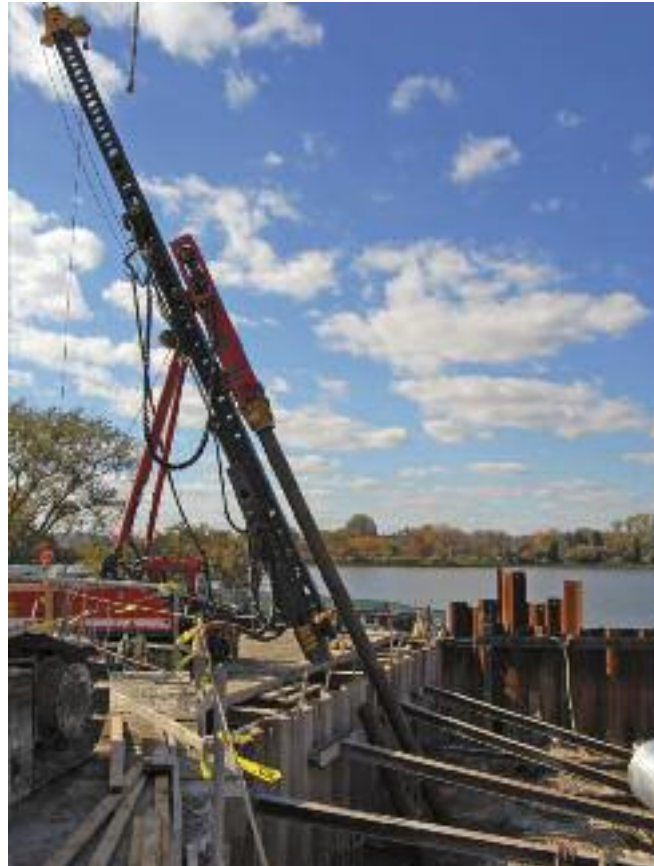
Pile driving rig reaches over to install battered pipe piles.

As caisson installation was nearing completion, battered pipe pile installation began. The 18 inch diameter pipe piles were installed with 25 or 35 degree batter and driven to refusal at bedrock. The pipe piles were prefabricated in two sections with a conical tip installed at the end schedule to bear at the bottom of the Tidal Basin and the top section with a splice collar to adjoin the two pieces. Due to the batter requirement, the piles were installed using a specialized ADSC Associate Member, Junttan* driving rig that could accommodate the unique requirement. After the piles were driven to refusal, the piles were filled with a concrete mix, placed from the bottom. Finally a reinforcing steel and steel plate assembly was wet stabbed in place to create a connection to the seawall structure above. Before piles were installed, a load test program was completed to verify actual bearing capacity achievable. Two vertical piles were installed within the west transition zone area with arc weldable gauges installed at four locations along the length of the pile. The test piles were driven in two pieces to accommodate the length to bedrock, and spliced with a full penetration weld. After completion of the driving activities, the gauges

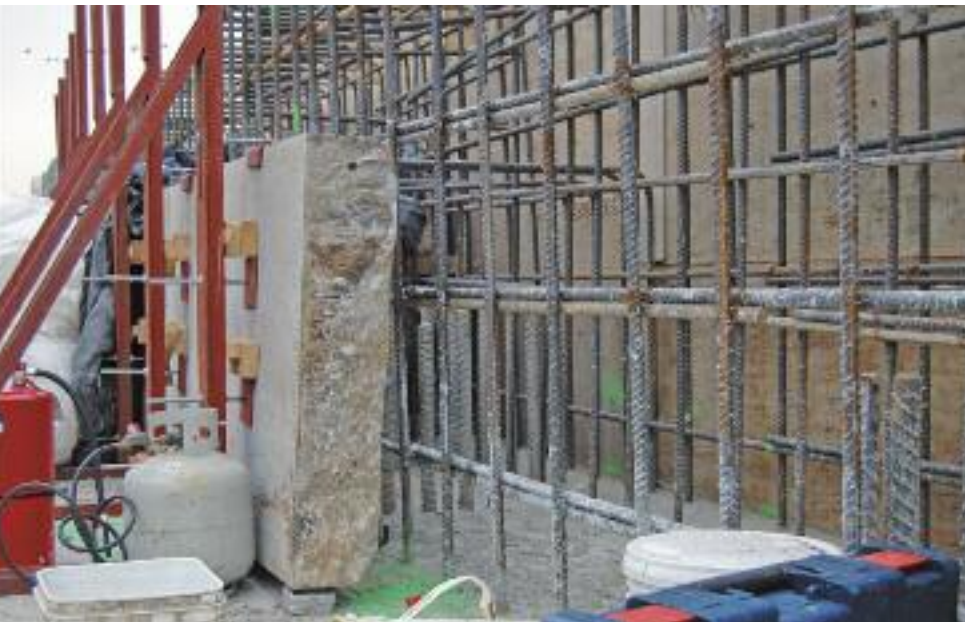
Original Ashlar facing stone re-positioned before pour of bottom section of the new wall stem.

and lower pour to align with the two courses of Ashlar facing stones. After the footing was poured, “A” frame style steel brackets were bolted to the horizontal surface of the seawall and vertically supported the Ashlar facing stones and secured the top of the stone to withstand the hydrostatic pressure of the concrete as it was placed from above. The stones were methodically placed in their original position and poured in sections of up to 70 linear feet long after the reinforcing steel was installed. After the bottom section had cured, the upper course of stone was set in the same method. The ultimate result was a monolithic structure where the historic stone is firmly attached to the concrete structure.
